### **Root Cause Assessment of KOH & Scrubber Water Discharge That Occurred on March 3, 2026**

**Event:** A spill of approximately 300 gallons of scrubber water containing potassium hydroxide (KOH) at a concentration of 0.5% occurred due to a discharge from the scrubber system (the “Scrubber”).

**Location:** Scrubber System, Silfab Solar, Fort Mill, SC

**Event Date:** Early Morning approximately 6:00AM of March 3, 2026

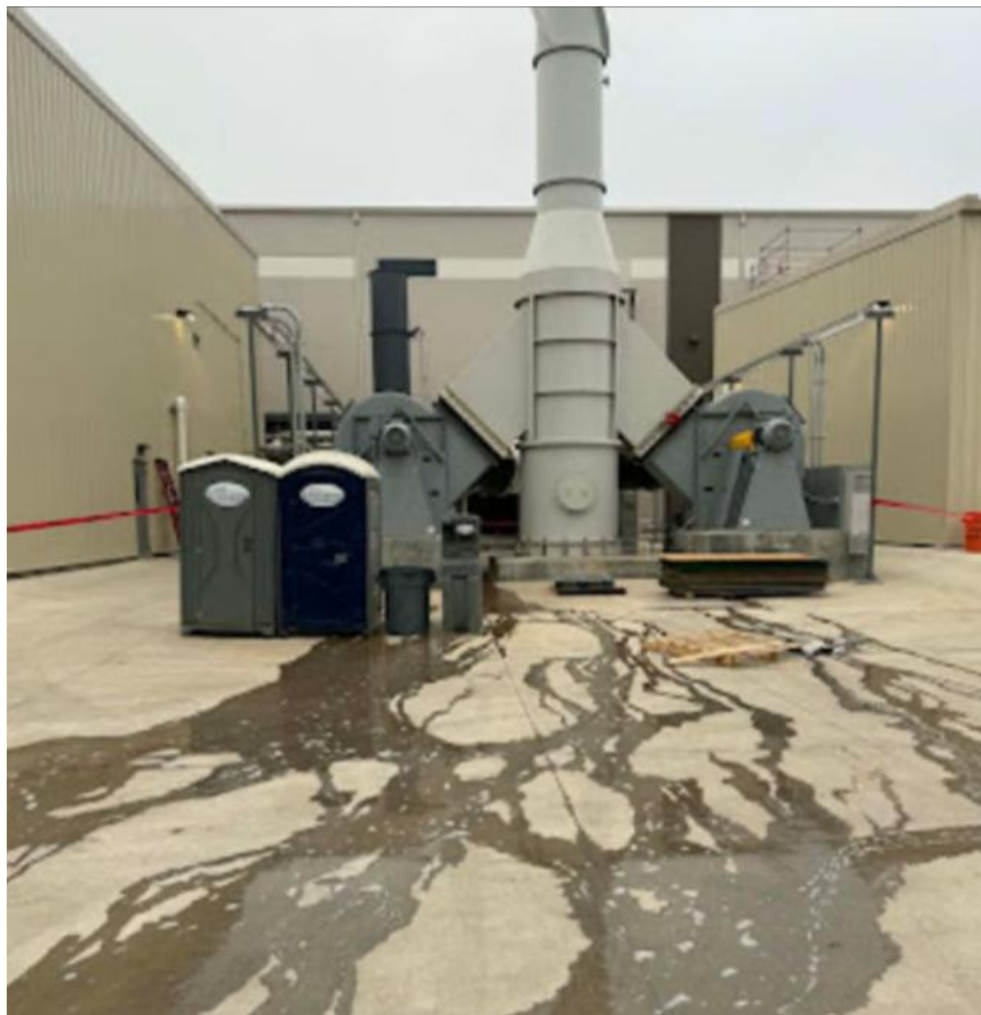
On March 3, 2026, during routine operator rounds, the Silfab Solar Scrubber was found to be leaking scrubber water (shown below). Silfab estimates that of the approximately 1,500 gallons contained within the Scrubber, approximately 300 gallons of scrubber water (leak rate estimated at 2 gallons per minute (gpm) for 2.5 hours) flowed across the back lot, approximately 110 feet to the nearest storm collection receiver.

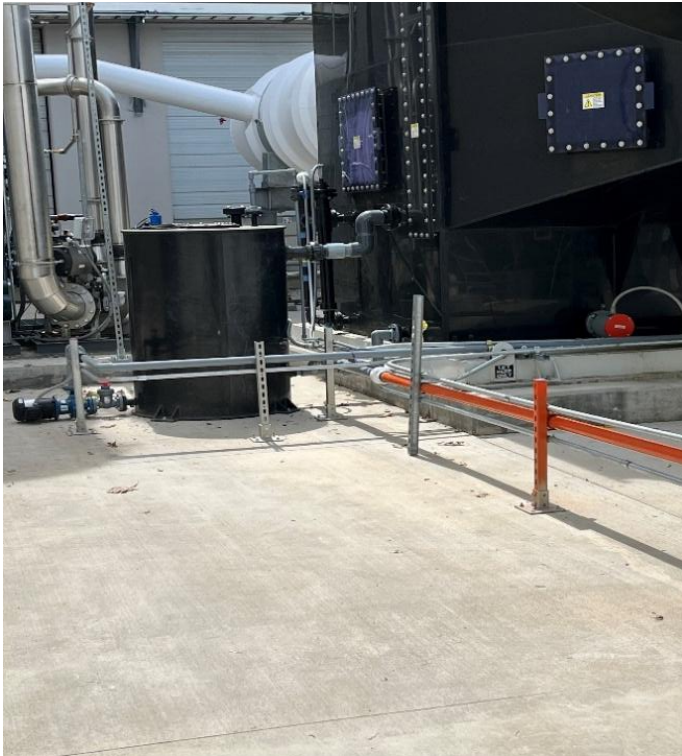
The Scrubber System is a packed bed scrubber where specialized-shaped packing media is packed into the main body of the Scrubber and utilized to increase surface area of the air filtration process. Internal exhaust vapor from acidic materials used in storage and processing is collected from the source of origin and pulled through the packed media of the Scrubber System forcing the acid vapor to make contact with the neutralizing agent, consisting of water and KOH. The KOH feed to the scrubber water is at a 45% concentration prior to its introduction into the water at which point it is diluted to maintain a neutral PH. The Scrubber is equipped with a basin and pumping system that delivers the neutralizing solution through spray heads located at the top of the Scrubber which allows the solution to spray down through the filter media making contact with the exhaust vapor, thereby neutralizing the exhaust before being emitted atmospherically. During operation, fresh water is added to the Scrubber through an automated makeup solenoid valve to maintain the proper water level in the Scrubber. The solenoid valve is designed to open and close based on the level detectors located in the Scrubber Basin. There is an additional interlock that will shut the Scrubber down if the water level falls below the low-low level. The valve opens to add fresh water at the low level setpoint and closes at the high-level set point. The solenoid valve malfunctioned, which was likely a direct result of the abnormally cold freezing conditions

that had occurred in the previous nights and atypical for this area, prior to the March 3<sup>rd</sup> incident. Due to the solenoid valve malfunction and not operating correctly, the operator opened the manual valve to add water into the Scrubber, based on the fluid level readings indicated on the control system operating screen. During the manual filling process, the high-high limit was inadvertently exceeded which in turn caused the level of the Scrubber to reach the overflow height, resulting in the scrubber water overflowing into the acid scrubber sump tank, shown below.

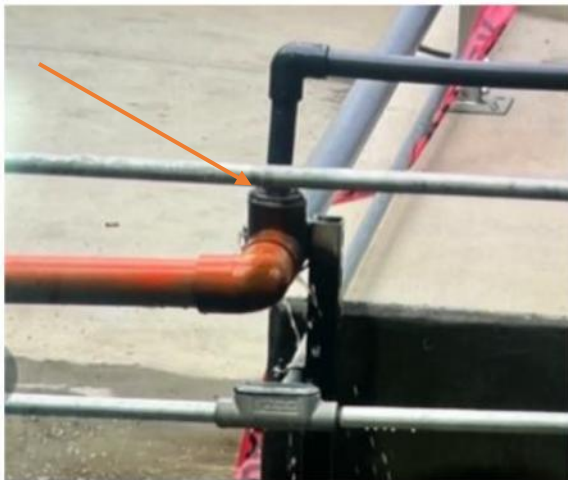
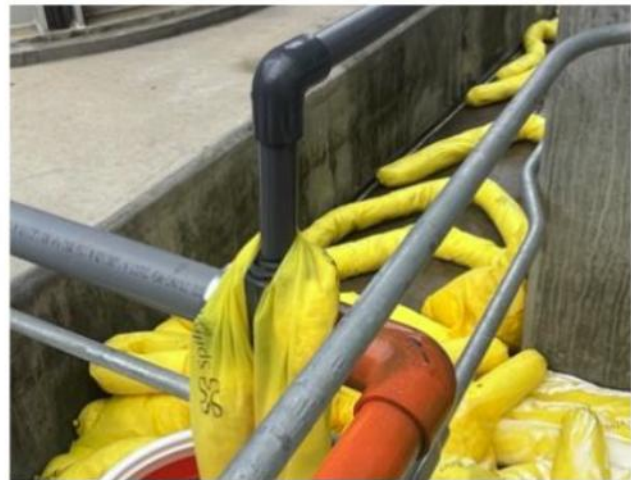
The scrubber sump tank drain line is also tied into the drain lines from the scrubber fan volutes. The overflow of the scrubber sump tank caused the tank to exceed the level at which the fan volute drain lines tie in (shown below). The drain line design and construction did not include a check valve at the time of the occurrence to prevent the scrubber sump water from back filling the fan drain lines as this condition would not typically be present with a properly functioning solenoid valve and no manual intervention. The elevated level resulted in the solution backfilling the fan volute drain lines and leaking out of a breach in the drain line. The drain lines

were also most likely impaired by the freezing conditions previously mentioned. The breach was discovered after the leak started to occur.

The pictures below show the breach and the leak location, as well as temporary containment elements (yellow lines).
